Matthew Kenny - Licensed Professional Real Estate Inspector

Address: 123 Main St, Anytown TX
Prepared for: Charlie Connors

ARMADILLO HOME INSPECTION

Property Location: 123 Main St, Anytown TX	Inspected By: Matthew Kenny	Insp Date: January 1, 2020
Prepared For: Charlie Connors	TREC License: #09997	Time: 9:00 AM

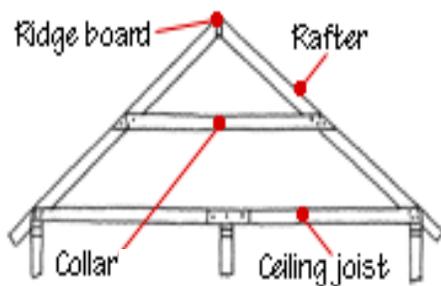
Attic Components

- e. Minimal separation of rafter to ridge connections observed. Gaps between rafters and ridge boards should be shimmed tight. However, separation was minimal and sporadic and no repairs recommended at this time.

- f. Small section of wall insulation has fallen from attic space in upper study closet to left of door. Recommend reinstallation.
- g. Under today's standards, recommended insulation R-value in an attic is R-38. *Approximate* depth of insulation to achieve this is 13-15" for loose fiberglass insulation, 10" for cellulose insulation, and 6.25" for properly rated fiberglass batt insulation. While home may be properly insulated for the period it was built, additional insulation can be added to bring attic up to R-38. (not recommended due to cost vs value)

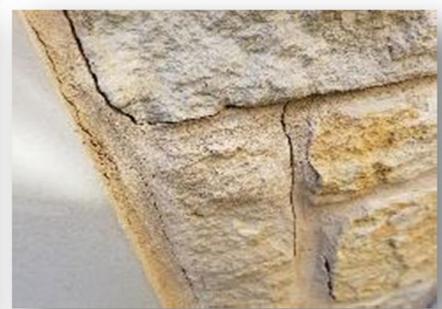
Item D

- d. NOTE - Light (less than 1/8") cracking of masonry mortar at several locations. These cracks are typical and do not appear to adversely affect the structure. No action required, but areas can be repointed or caulked to prevent water intrusion.

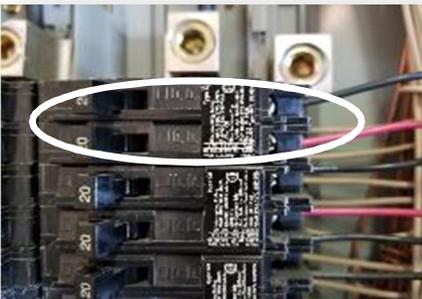
Item Q

- q. Trip ties are required where a 4-wire cable (two hots, a neutral, and a ground wire) is split between two breakers sharing the common neutral. Trip tie ensures that both breakers will trip simultaneously. This is missing at two top right breakers.

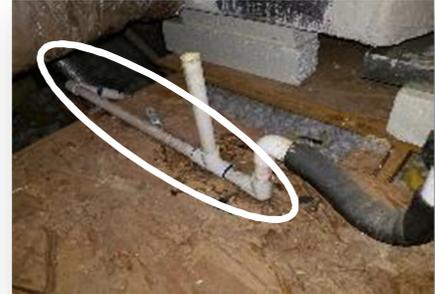
Item K

- k. The primary condensate drain line at both HVAC units is lacking insulation which is required to prevent sweating, or condensation drip, onto attic floor which may eventually cause staining to the drywall ceiling below. Recommend insulating entire length of line.

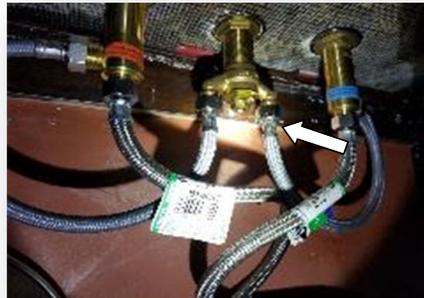
Item P

- o. Recommend adding clamp to HVAC condensate line where it attaches to p-trap under left jack and jill sink to prevent leaks.
- p. Heavy leak to water line connections under master hall bath faucet during use. Repair required.
