Matthew Kenny - Licensed Professional Real Estate Inspector

Address: 123 Main St, Austin

Insp Date: January 1, 2017
Time: 2:00 PM

SECTION 3: DETAILED REPORT

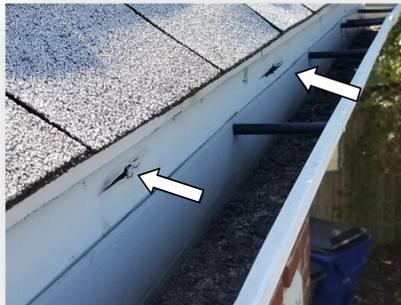
Item E

- e. Some isolated decay to fascia around fasteners observed. No repair required at this time.
- f. Plumbing pipe vent stacks must have caulking at the rubber flashing to pipe connection to prevent water from entering home when rubber inevitably deteriorates (even when the pipe penetration is an 'Oatey No-Caulk' or similar flashing.)

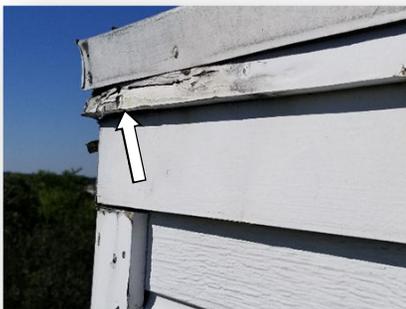
Item G

- g. Decay found at chimney top fascia board. Recommend caulking gaps to prevent further decay.
- h. Upslope side of chimney is lacking a cricket (a raised, triangular shaped portion of roof against the back side of the chimney) to properly divert water away from the face of the chimney. It is recommend a cricket be added during the next re-roof. Until then, keep this area clear of leaves and debris that will inhibit

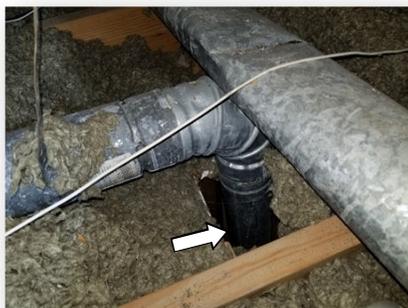
Item F

- e. Attic access stairs from garage is required to be fire rated (not commonly seen in older construction).
 - f. A firestopping collar is required where the hot water heater flue penetrates into the attic in order to maintain adequate clearance between the flue and combustible material and to maintain a fire break between living space and attic space.

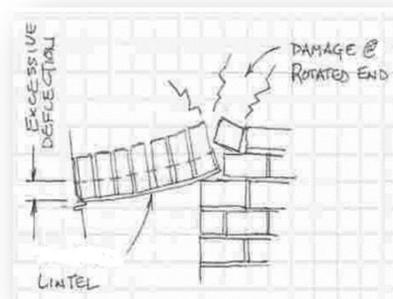
Item F

- f. A sagging lintel over the garage door has lead to settlement cracking of masonry above the center of the span, as well as stress cracking of the masonry to either side of the header. Further, the masonry atop this lintel appears to be leaning, or rolling, forward. It is theorized that this is due to the lintel being a flat piece of steel rather than an 'L'-shape, and the projection of the brick over the garage door header is causing forward movement. Recommend monitoring condition and repairing if condition worsens.

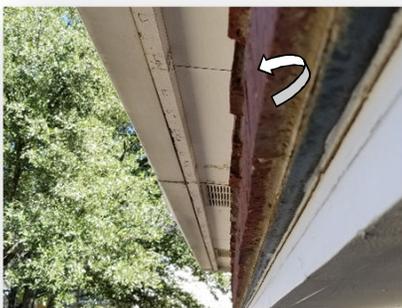
Item F (view from below looking up)

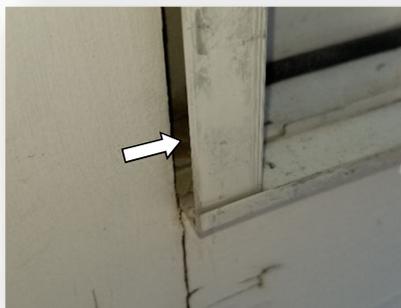
Item G

- g. Recommend caulking gap between window trim and window frame along 2nd level at rear of home to prevent water entry and decay.

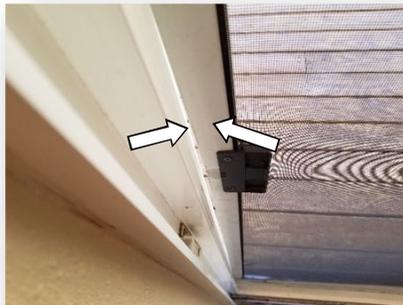
Item G

- f. Closet doors have been removed from both guest bedrooms.
 - g. Screen door at living room slider is slightly bent and does not close properly.
 - h. Bottom of garage door leading to laundry room does not form a tight seal at the bottom. Recommend installing a threshold seal or weatherstrip.

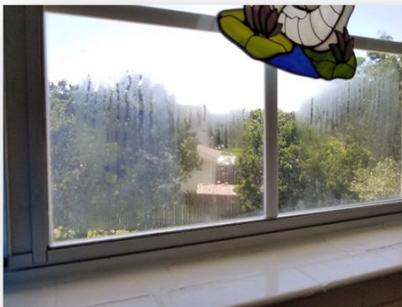
Item B

- b. The insulating seal between the panes of glass is compromised and/or desiccant strip is deficient at the bonus room upper right window and guest bath window as evidenced by fogging and/or condensation.
- c. Minor swelling to interior window sills at living room window due to moisture damage. This is common and can be caused by leaving the window open during rain, but may also be caused from condensation ("sweating") accumulating on the inside face of the window. This condensation could be an indication of a broken window seal that does not yet show visual evidence.
- d. Screens are missing from west master bedroom, both guest bedrooms, master bath, and kitchen windows.

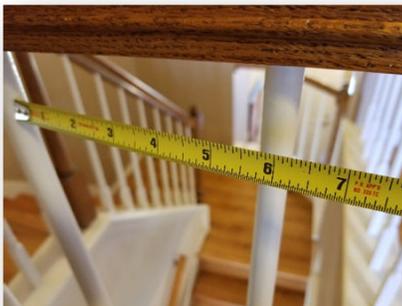
Item A

1. Guardrails
 - Provided where required? Yes No n/a (walls in place)
 - Spacing of balusters? Acceptable In need of repair n/a (walls in place)
 - Secure? Yes No n/a (walls in place)
2. Grippable handrail Yes No N/A
3. Open risers Yes No N/A
4. Comments:
 - a. Current building standards require that no guardrail or railing opening on stairs permit the passage of a sphere greater than 4". The spacing between balusters is currently 5-1/2".

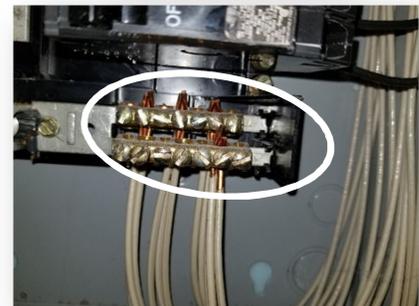
Item L

- k. Neutral bar in subpanel has doubletaps (i.e. two or more wires share the same screw). While this is acceptable for ground wires, this is against standard practice for neutral wires.
- l. A garage shelf has been installed in front of the subpanel cover, preventing access to one cover screw and complete removal of the panel cover. Shelf should be removed.

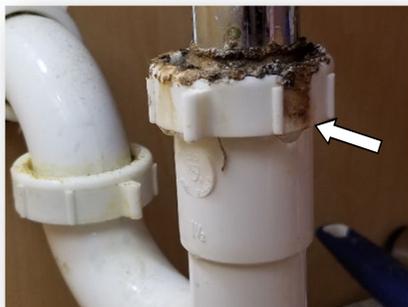
Item C

1. Overflows on bath sinks: Yes No
2. Comments:
 - a. NOTE - inspector runs bathroom fixtures for 5-10 minutes in an attempt to discover backups or clogs in the main external sewer lines. Although this is not part of a normal inspection procedure and this is excluded from the scope of this inspection, no backups were observed as part of this limited test.
 - b. Master sinks slow to drain. Drain cleaning recommended.
 - c. Active leak at p-trap of guest bath sink.

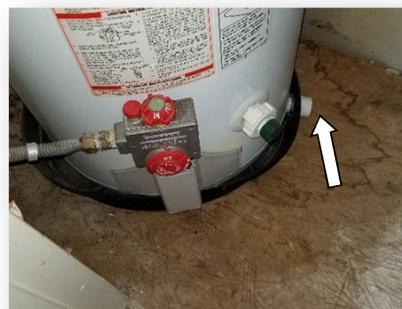
Item I, J

- I The water heater emergency drain pan is lacking a drain pipe. Should this pan fill with water in the event of a leak, water will leak into garage, but also into adjacent living space.
- J The closet plywood base is sagging under the weight of the water heater and is weakened by a prior water heater leak. This should be replaced when water heater is replaced.
- K Evidence of flame roll-out (flame escaping combustion chamber and staining the exterior of the water heater tank) is evident. Repair recommended.
- I Water heater, although functioning, is near the end of its serviceable life and a budget should be set aside for replacement in the near future.
