Matthew Kenny - Licensed Professional Real Estate Inspector

Address: 123 Main St, Anytown TX
Prepared for: Charlie Connors

ARMADILLO HOME INSPECTION

Property Location: 123 Main St, Anytown TX	Inspected By: Matthew Kenny	Insp Date: January 1, 2020
Prepared For: Charlie Connors	TREC License: #09997	Time: 9:00 AM

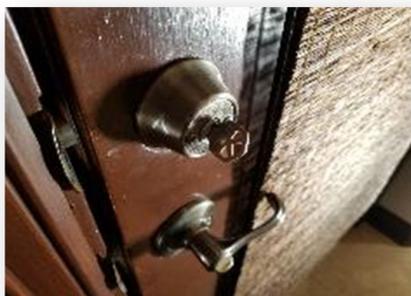
Item F

- f. Rear kitchen and master bedroom exterior door deadbolt is operated by key on the inside face. Thumbturn deadbolts are required in lieu of keyed deadbolts on exterior doors for quick egress in the event of an emergency.

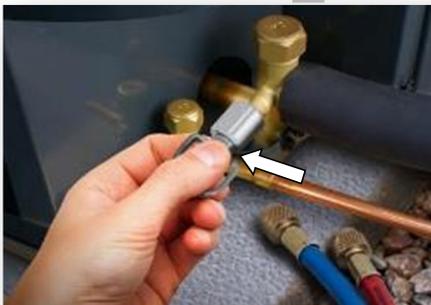
Item B (locking caps - sample photo)

- a. Exterior condenser(s) manufactured on date noted above and with the exception of the below, is functioning properly at time of inspection. Typical life expectancy for this type of equipment is approx 15-20 years but can be extended with proper maintenance.
- b. NOTE - The City of Austin and some other jurisdictions have recently begun requiring refrigerant lock caps on condensers. This is only sporadically enforced and repair not recommended.
- c. NOTE - The City of Austin and some other jurisdictions have recently begun requiring refrigerant line insulation UV protection wrap on outside condensers. This is only sporadically enforced and repair not recommended.

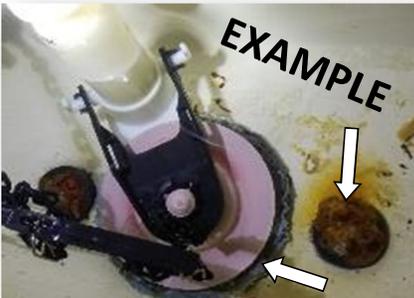
Item F (example)

- f. MAINTENANCE TIP - over time, toilet flappers (red disc in photo below) can become worn which will result in a toilet that drips water into the toilet bowl, causing tank to refill periodically. Toilet tank bolts (see photo) can also become rusted and leak. Recommend changing out these parts every 5-10 years.

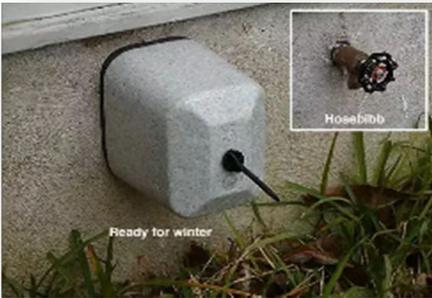
Item G (example)

- g. MAINTENANCE TIP - Exterior hose bibs should be insulated in the winter months using an insulating cover like that show in the photo below to prevent freezing and cracking of water lines.

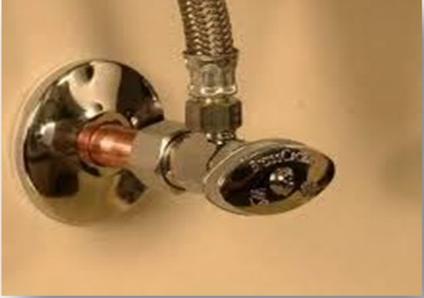
Item H (example)

- h. MAINTENANCE TIP - shutoff valves below toilets and kitchen / bath faucets tend to corrode over time on the exterior while the rubber stoppers on the inside disintegrate. This can cause leaks when valve is operated, or cause valve to not fully stop the flow of water when turned off. This is a maintenance item that requires sporadic repair on most homes.

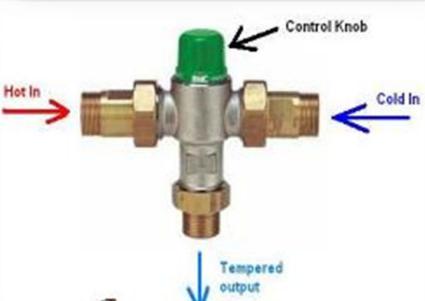
Item I (example)

- i. Thermostatic mixing valves are required by newer building standards in tubs with separate hot & cold handles to limit water temperature and prevent scalding. No thermostatic mixing valve was found; code requires the valve be accessible when present.

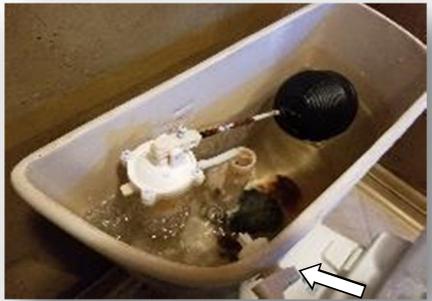
Item J

- j. Master toilet handle is loose and allows excess handle chain to become trapped under the flapper, causing toilet to run. Repair required.
- k. Master hall bath toilet flapper in fill tank is worn and requires replacement. This flapper allows water to slowly trickle from the tank to the bowl, and will cause the tank to automatically refill sporadically.

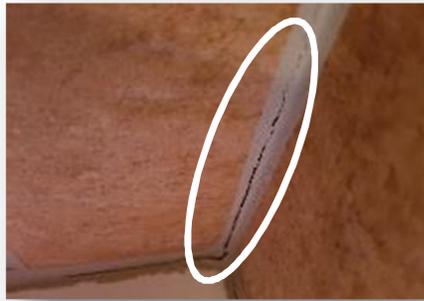
Item L

- l. Inside corners of both upper shower walls are recommended to be sealed with flexible sanded caulking in lieu of grout to seal cracking that would allow water to enter wall cavity. If the corners have not cracked yet, most do eventually without flexible caulking.

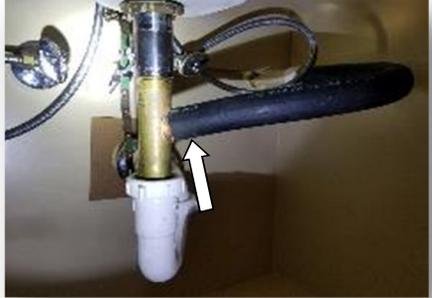
Item O

- o. Recommend adding clamp to HVAC condensate line where it attaches to p-trap under left jack and jill sink to prevent leaks.
- p. Heavy leak to water line connections under master hall bath faucet during use. Repair required.

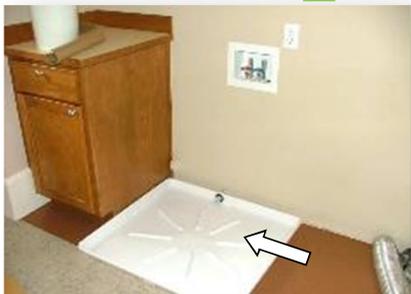
Item D (example)

- d. Drain pans are recommended under clothes washers in the event of leaks/spills (although a drain line is not present in the wall for this purpose and would need to be added).

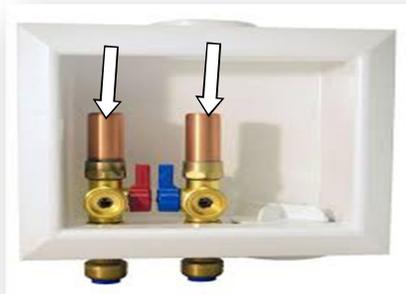
Item E (example)

- e. Water hammer arrestors are recommended on all washer hookups.

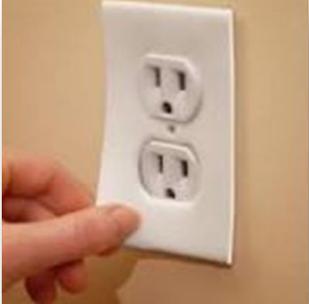
Item D (example of foam seal)

- d. The use of insulating foam seals behind all outlet and switch faceplates is an easy way to reduce conditioned air loss through your exterior walls and increase your energy efficiency.
