Matthew Kenny - Licensed Professional Real Estate Inspector

Address: 123 Main St, Austin

Insp Date: January 1, 2017
Time: 2:00 PM

SECTION 3: DETAILED REPORT

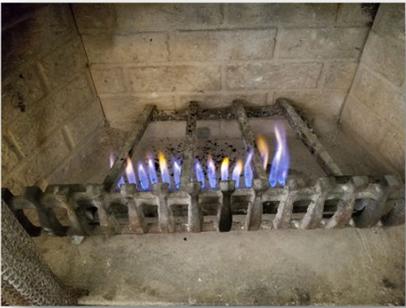
8. Comments:
 a. Monitor creosote buildup in wood burning fireplaces as excessive buildup is a leading cause of house fires.

Fireplace in operation

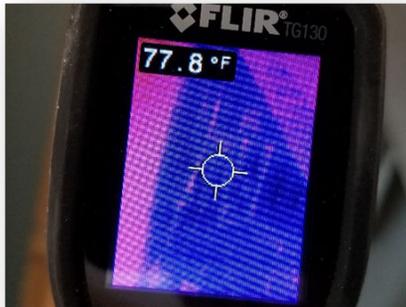
Infrared imaging of panel (OK)

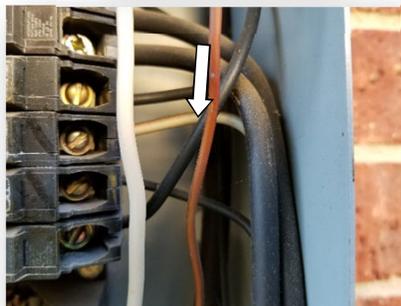
Item K

- k. Neutral bar in subpanel has doubletaps (i.e. two or more wires share the same screw). While this is acceptable for ground wires, this is against standard practice for neutral wires.
- l. A garage shelf has been installed in front of the subpanel cover, preventing access to one cover screw and complete removal of the panel cover. Shelf should be removed.

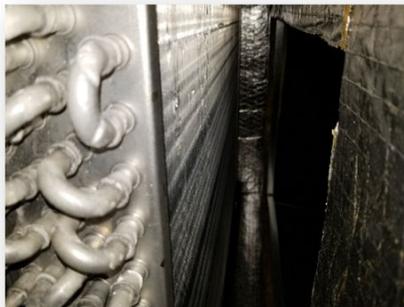
Interior of HVAC unit (OK)

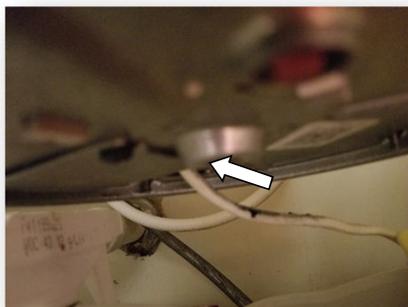
Item B

- Elec grommet installed: Yes No
- GFCI protected: Yes No
- Comments:
 - BUYER TIP - regularly running ice cubes through disposal is a great way to abrasively clean the interior of the disposal unit and remove rust and food particles from blades.
 - A clamp or grommet is required to prevent damage to wiring where it enters bottom of disposal.
